**COAL ASH IMPOUNDMENT
SITE ASSESSMENT DRAFT REPORT**

**6th Street Power Generating Station
Alliant Energy
Cedar Rapids, Iowa**

KLEINFELDER PROJECT NUMBER 118953-4

May 2, 2012

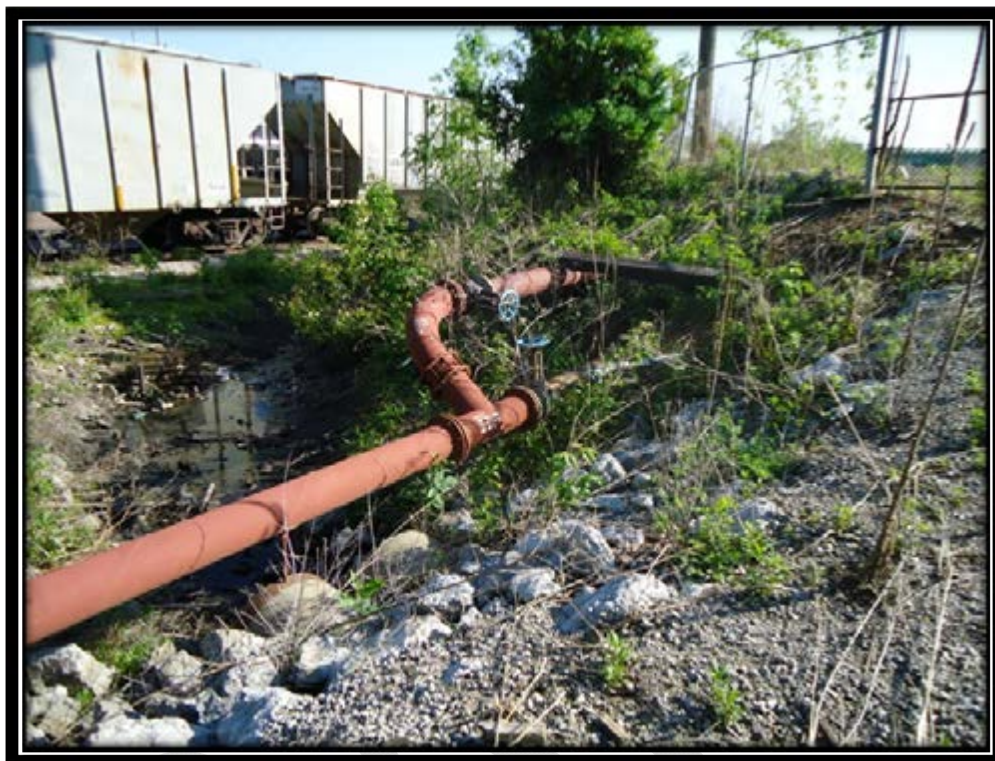
The toe area of the embankment was in fair to poor condition. Photos 1 and 32 at the end of this section show the conditions of the downstream toe. Key features and observations of these areas include:

- Grasses and woody bushes were observed on the downstream slope/toe for the majority of the northwestern embankment.
- A stormwater ditch was present at the northwestern embankment downstream toe with water that was constantly flowing during the assessment.

Photo 1 – Discharge Pipes into Ash Ponds
May 24, 2011 NPDES# IOWA-5715109

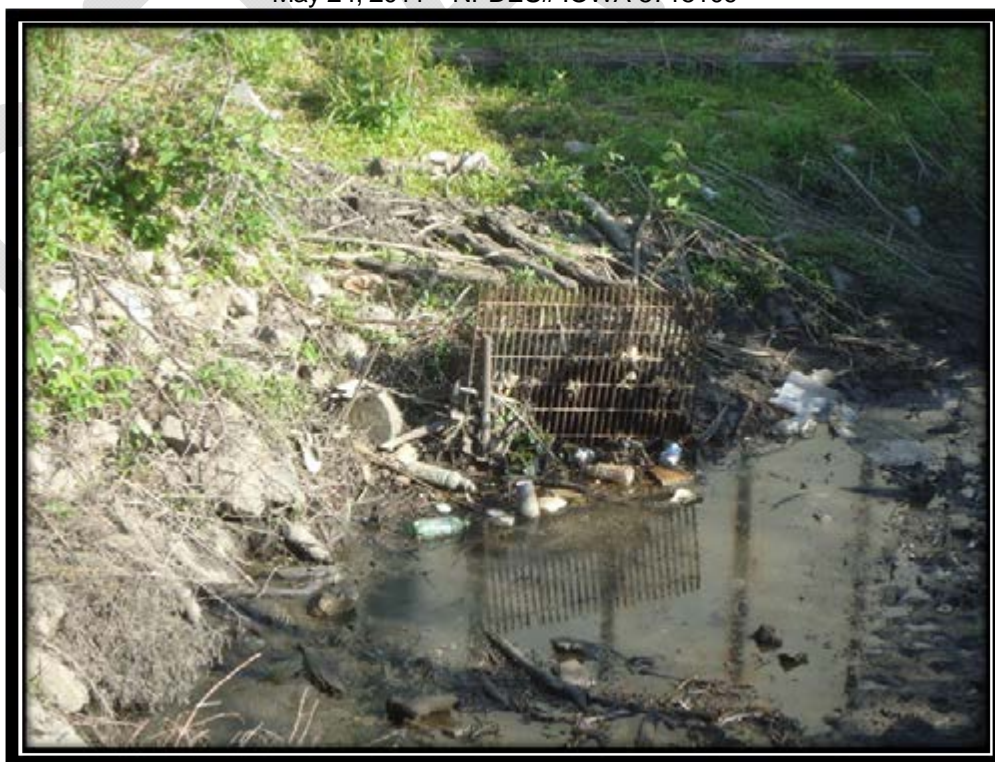
Photo 2 – Corrugated Metal Pipe (CMP) Discharge under Railroad Tracks into Cedar Lake
May 24, 2011 NPDES# IOWA-5715109

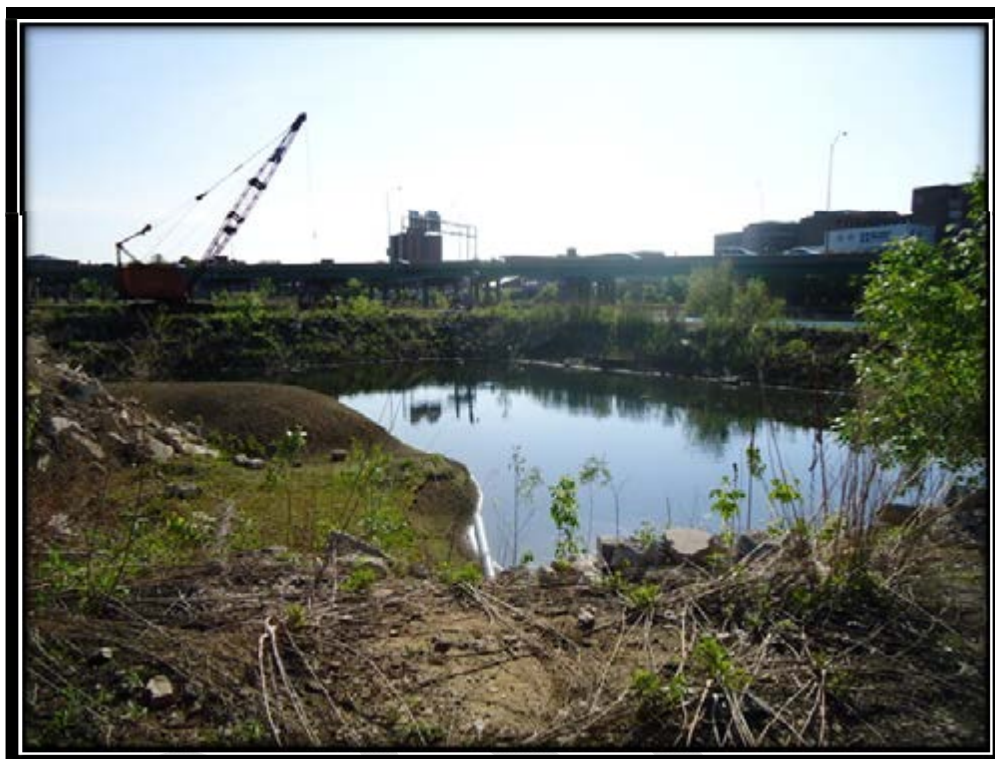
Overall, the upstream slope of the impoundment was in fair condition. Photos 3 and 4 at the end of this section show the conditions of the upstream slope. Specific observations include:

- The upstream slope was laid back at approximately 2H:1V.
- Minor erosion, less than 6 inches, was noted on some of the upstream slopes
- Vegetation was present on the majority of the upstream slope. Vegetation with stem diameters greater than one inch were noted during the assessment.
- Mowing/vegetation control had not been completed on the majority of the upstream slope.
- Riprap/concrete rubble was present on the upstream slopes. It was typically intermittent and sparse.

Overall, the crest of the impoundment was in fair condition. Photos 3 and 4 at the end of this section show the conditions of the crest. Specific observations include:

- The impoundment crest consists of a graded gravel used as an access route placed on top of the impoundment embankment.
- Overall, the crest was clear of vegetation with only some sparse grasses and minimal bushes observed on the crest.
- No major depressions or rutting were noted on the impoundment crest.
- A chain link fence is located on the southwestern and northwestern sides of the ash pond at the crest. The chain link pole penetrations are located on the crest near the downstream gradebreak.
- Minor erosion was noted on the crest in limited locations. This erosion was typically less than six inches in depth and typically appeared on the edges of

Photo 3 – General Conditions Photograph Ash Pond 1
May 24, 2011 NPDES# IOWA-5715109

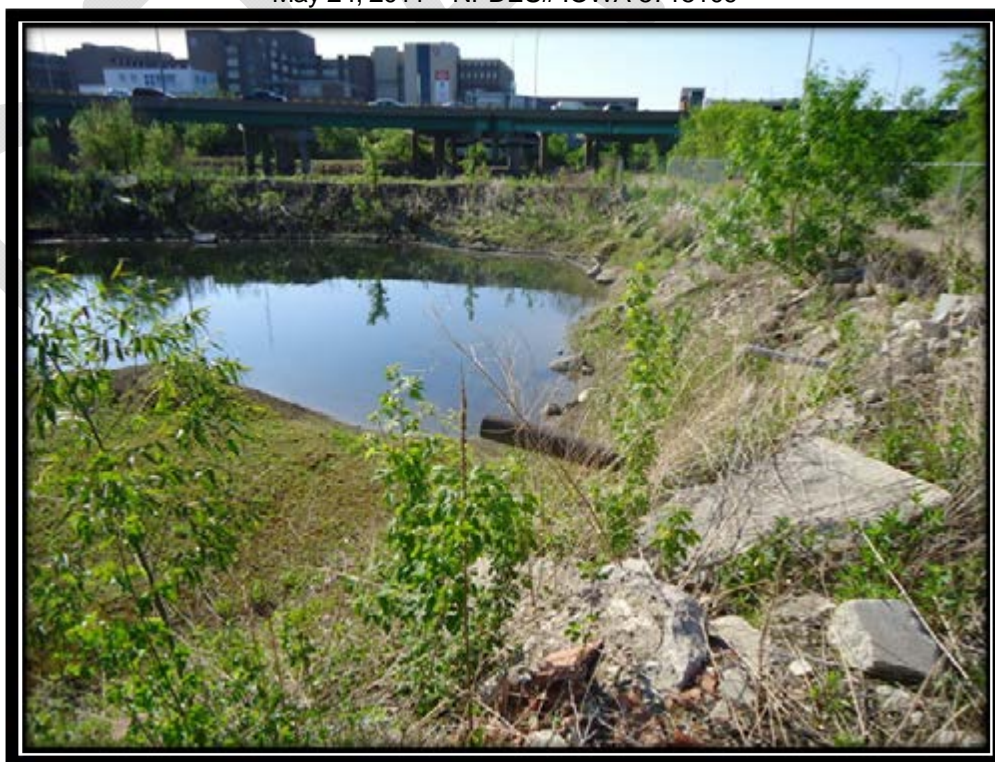
Inflow into Ash Pond 1 is via metal piping on the southwestern corner of the impoundment, as well as stormwater runoff that flows naturally into the pond. From this southwest inlet location, the CCW slurry water/floor sump water, flows directly into the pond via a cantilevered metal pipe. The inlet pipe appeared to be in fair condition, and can be seen in Photo 4 at the end of this section.

Photo 4 – Sluice Pipe into Ash Pond 1 (note small trees in embankment)
May 24, 2011 NPDES# IOWA-5715109

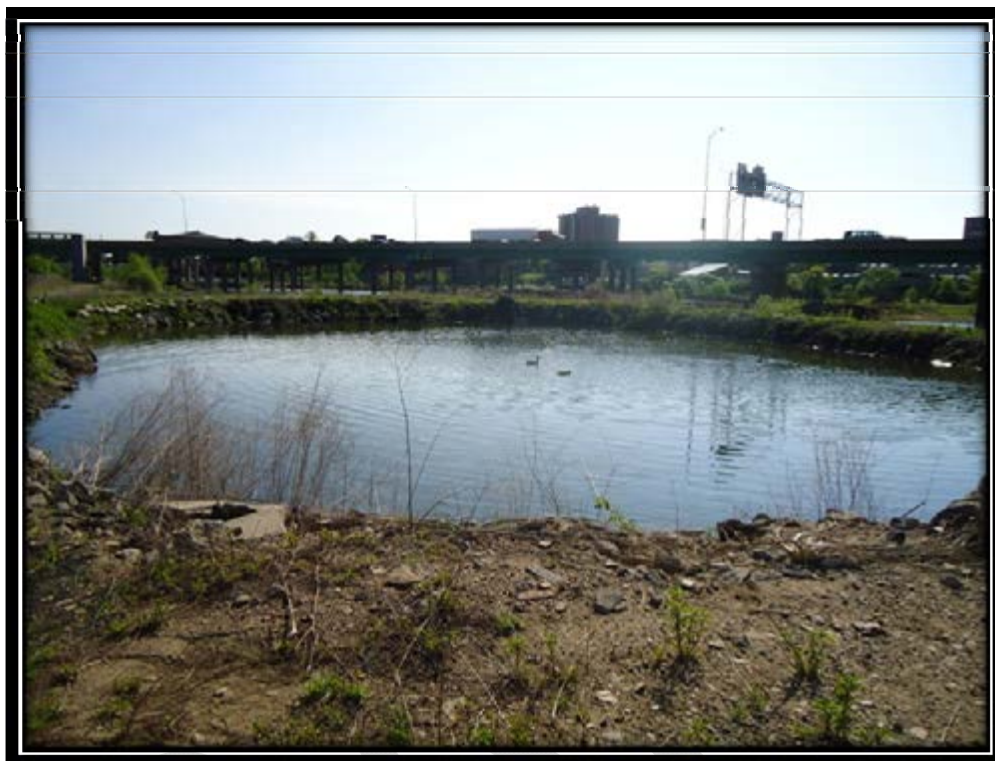
Overall, the upstream slope of the impoundment was in fair condition. Photos 5 through 8 at the end of this section show the conditions of the upstream slope. Specific observations include:

- The upstream slope was laid back at approximately 2H:1V.
- Grasses and woody bushes were observed on the upstream slope. No vegetation with a stem diameter greater than 1 inch was noted during the assessment.
- Minor erosion, less than 6 inches, was noted during the assessment on the upstream slopes.
- Riprap/concrete rubble was present on the upstream slopes. It was typically intermittent and sparse.

Photo 5 – General Conditions Photograph Ash Pond 2
May 24, 2011 NPDES# IOWA-5715109

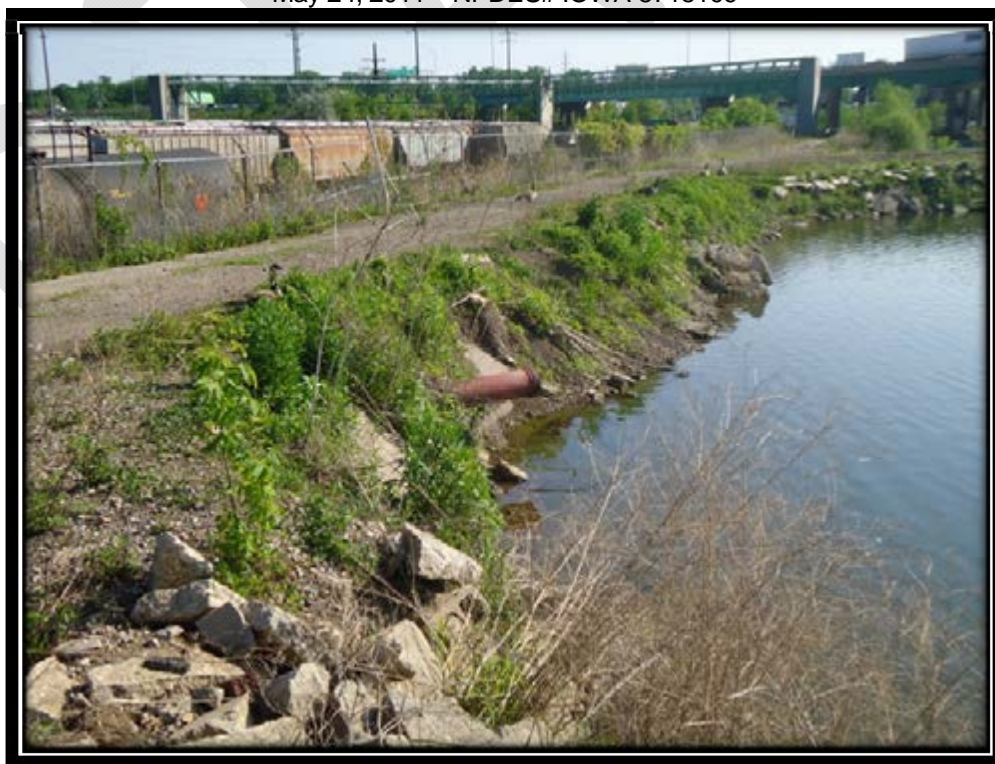
Overall, the crest of the impoundment was in fair condition. Photos 6 and 7 show the condition of the crest. Specific observations include:

Photo 6 – Inlet Pipe into Ash Pond 2
May 24, 2011 NPDES# IOWA-5715109

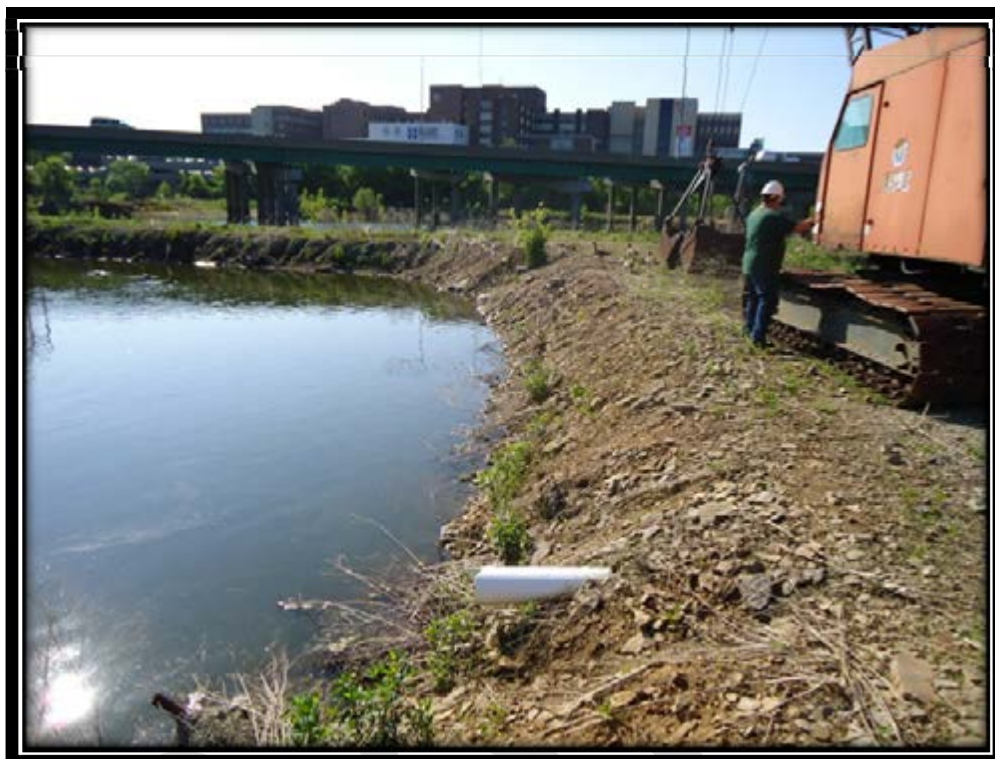
Photo 7 – 12 Inch PVC Pipe Hydraulically Connecting Ash Ponds 1 and 2
May 24, 2011 NPDES# IOWA-5715109

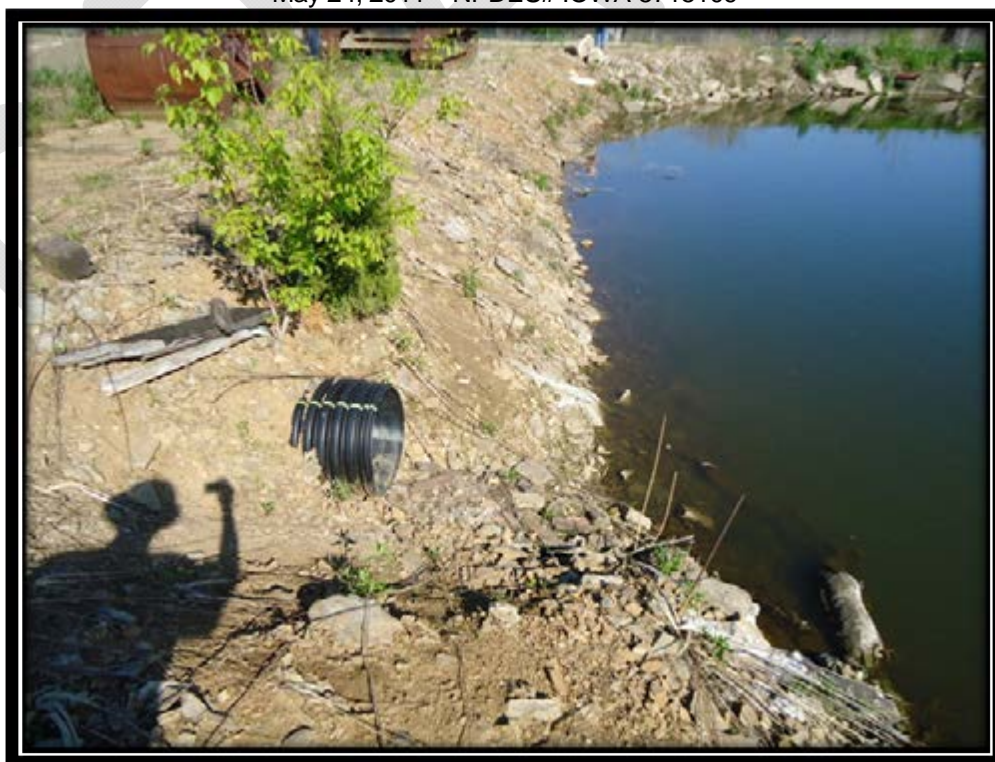
Photo 8 – 30 inch Corrugated Plastic Pipe Hydraulically Connecting Ash Ponds 1 and 2
May 24, 2011 NPDES# IOWA-5715109

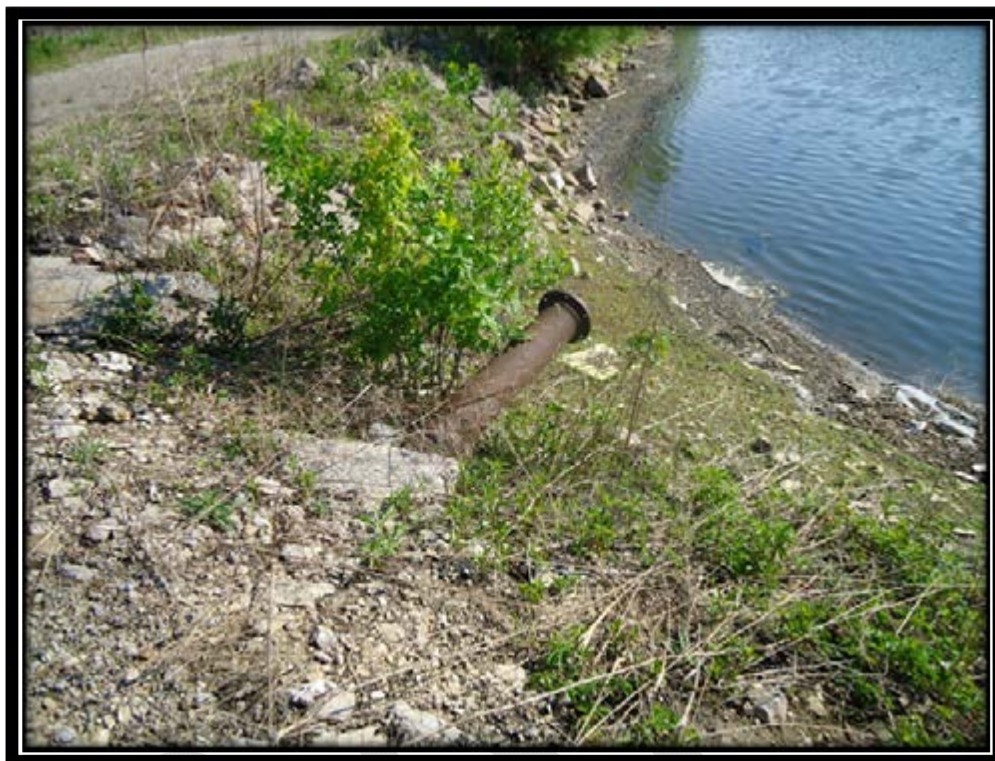
Photo 11 – Ash Pond 3 Unknown Sluice Pipe Approximately 8 Inch Cast Iron Pipe
May 24, 2011 NPDES# IOWA-5715109

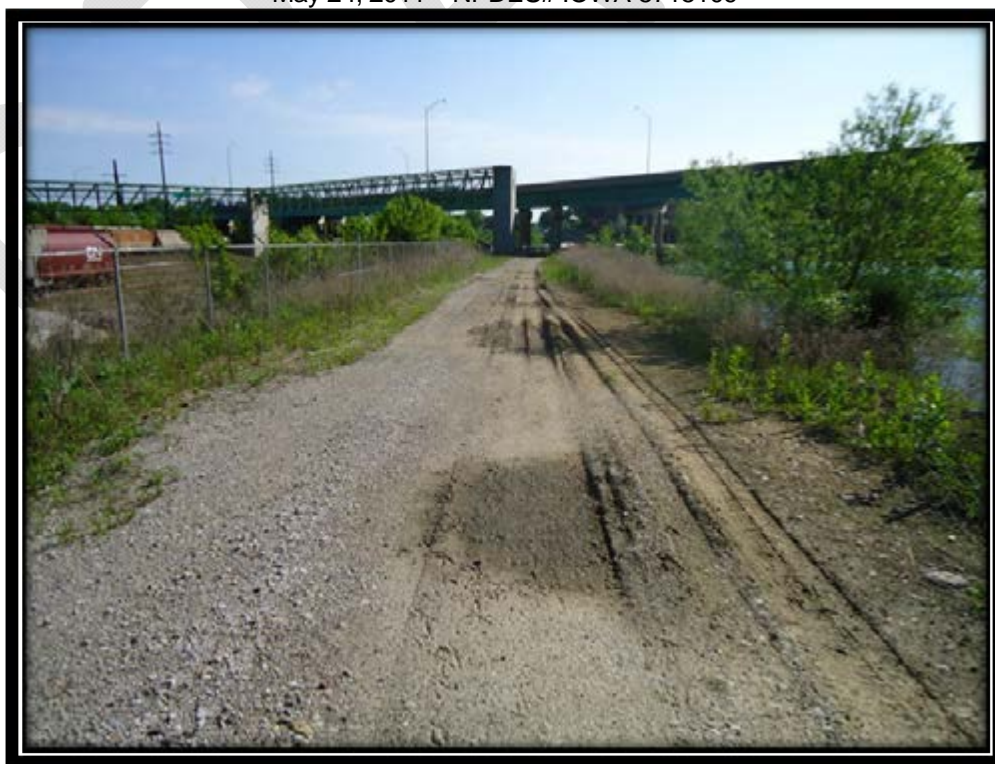
Photo 12 – Ash Pond 3-6 Inch Rutting on Crest
May 24, 2011 NPDES# IOWA-5715109

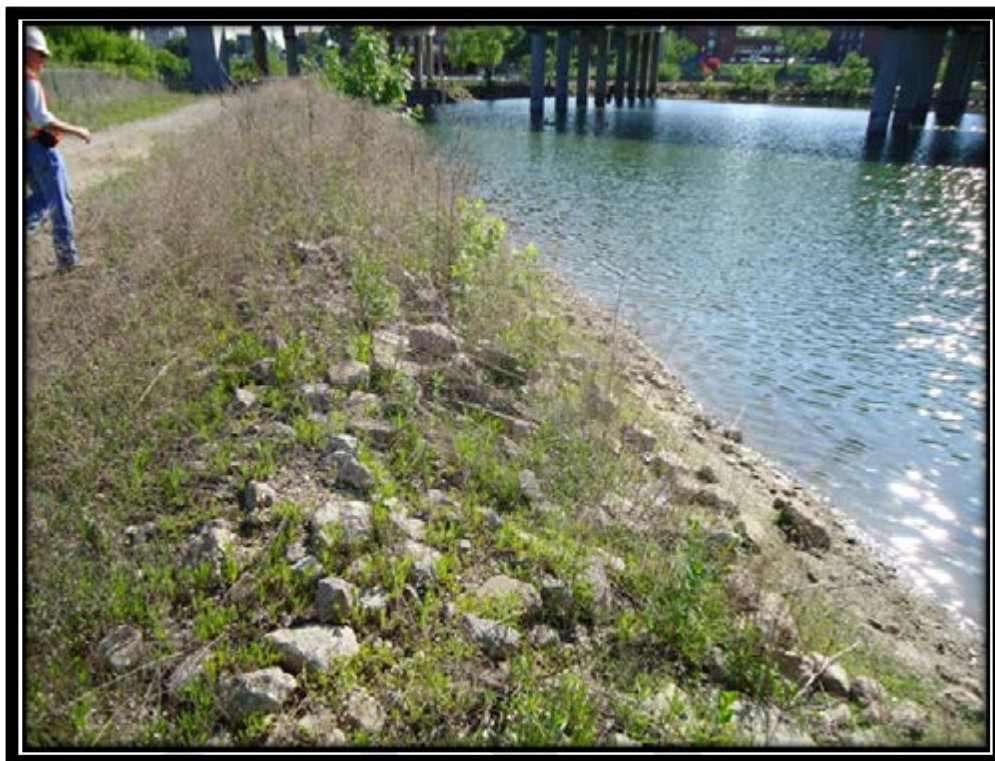
Photo 13 – Ash Pond 3 Vegetated Riprap
May 24, 2011 NPDES# IOWA-5715109

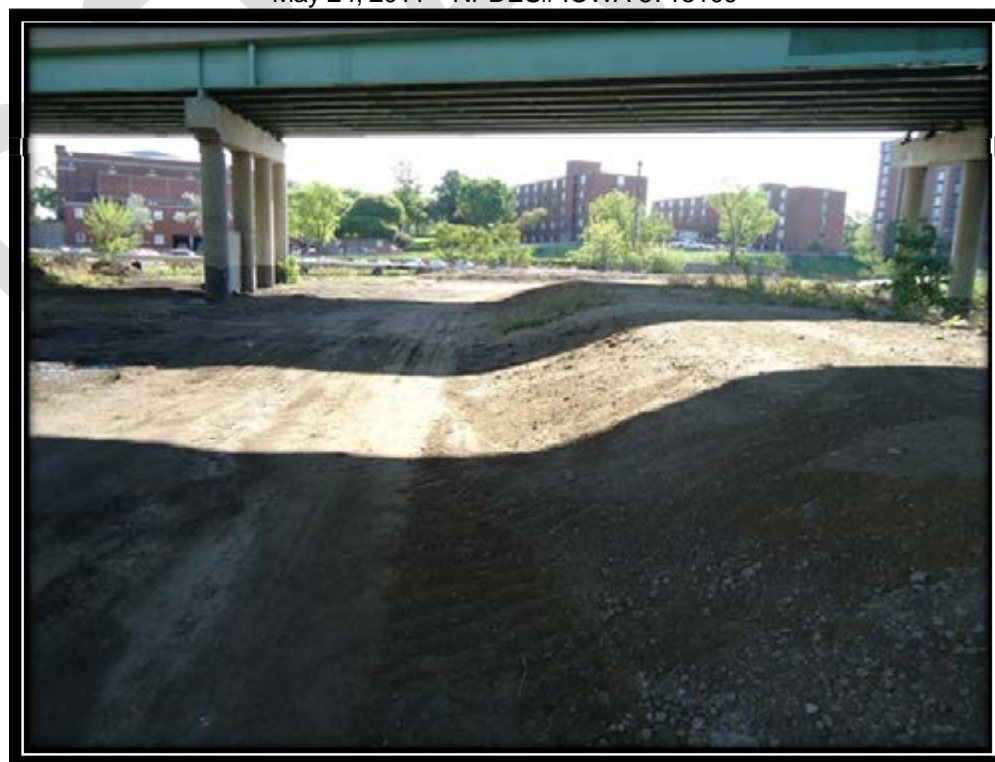
Photo 14 – Ash Pond 3 Embankment (note lack of vegetation)
May 24, 2011 NPDES# IOWA-5715109

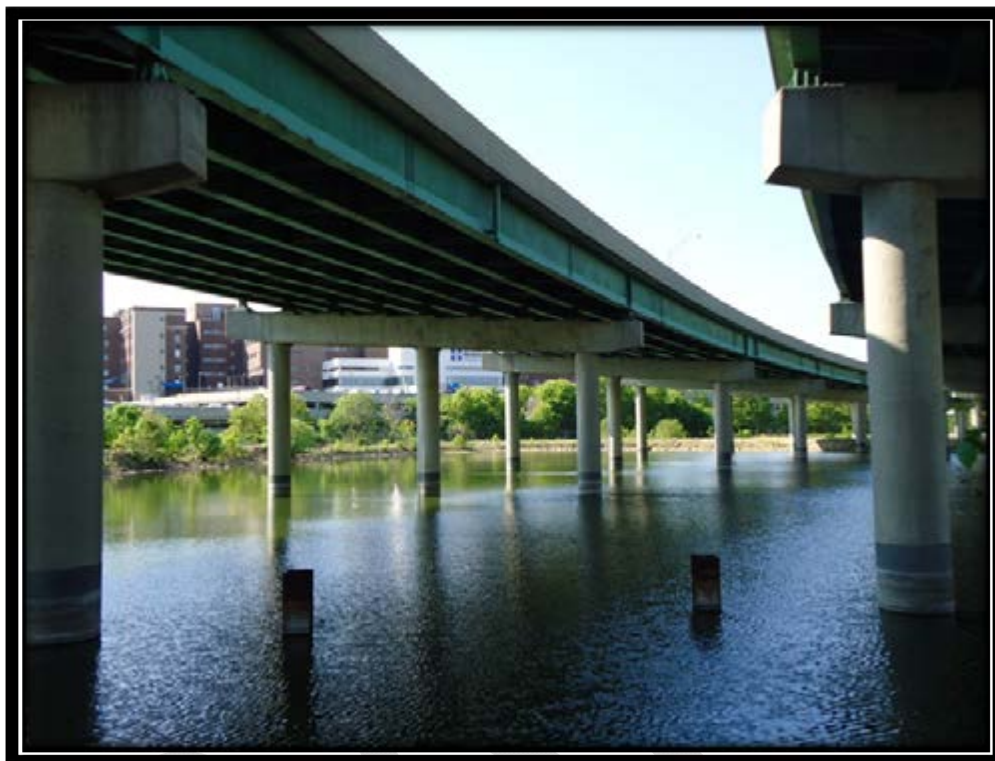
Photo 15 – Downspout from Highway Discharging into Ash Pond 3
May 24, 2011 NPDES# IOWA-5715109

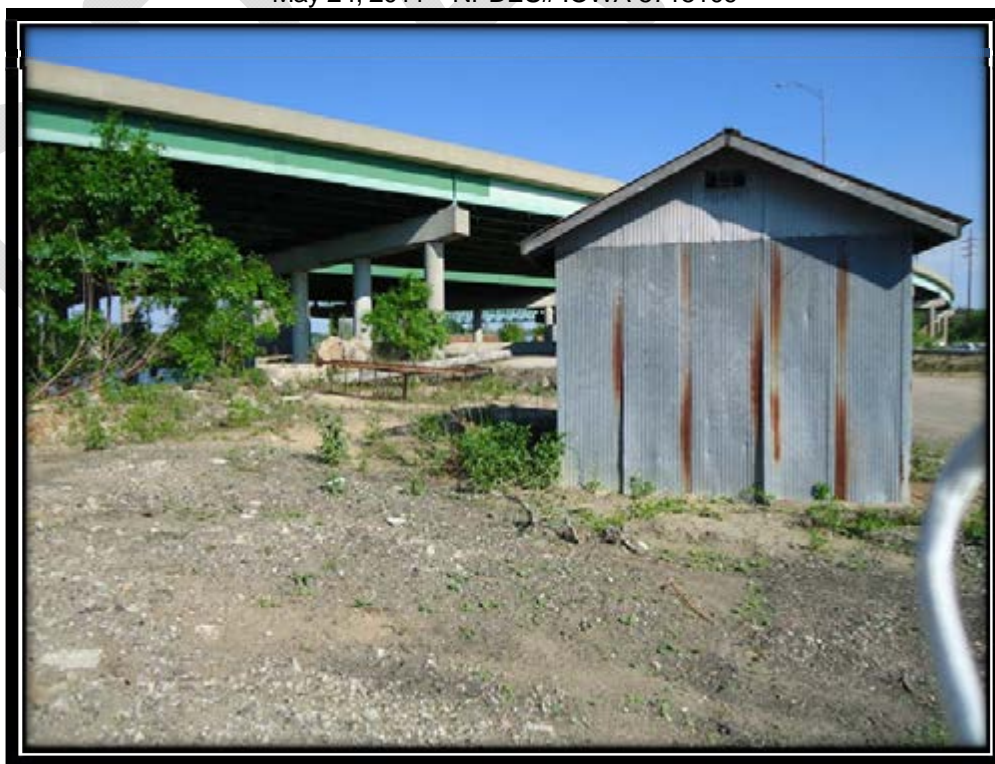
Photo 16 – Debris and Abandoned Building on Crest of Ash Pond 3
May 24, 2011 NPDES# IOWA-5715109

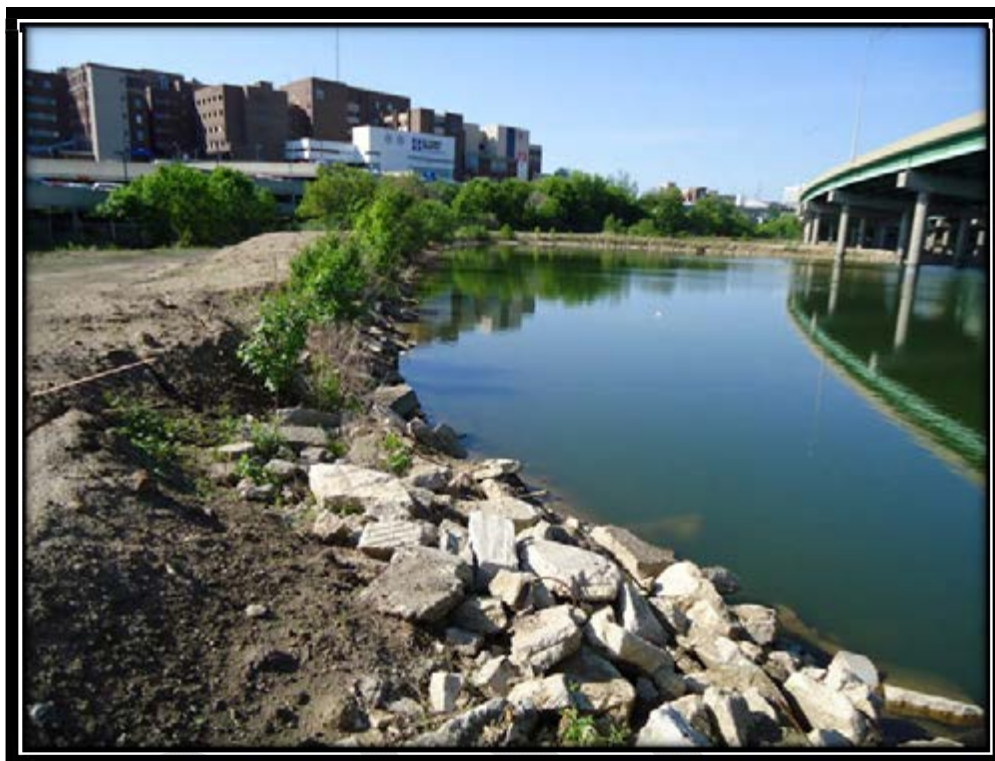
Photo 17 – Ash Pond 3 Concrete Rubble Riprap
May 24, 2011 NPDES# IOWA-5715109

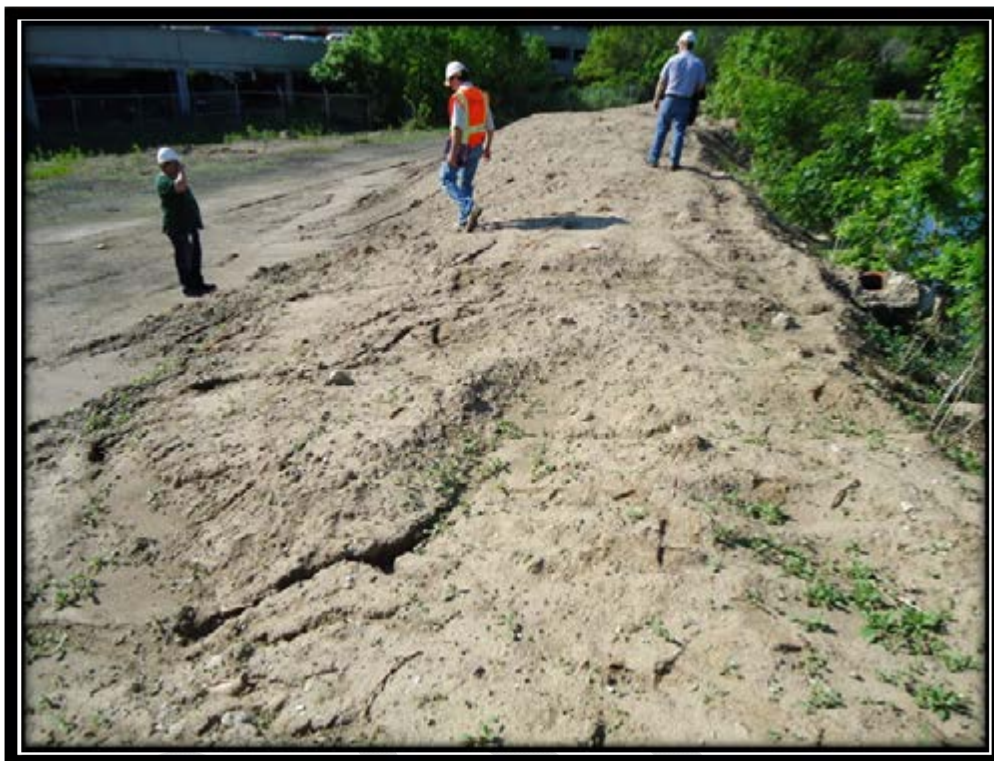
Photo 19 – Ash Pond 3 Embankment (note uncompacted soil with a lack of vegetation)
May 24, 2011 NPDES# IOWA-5715109

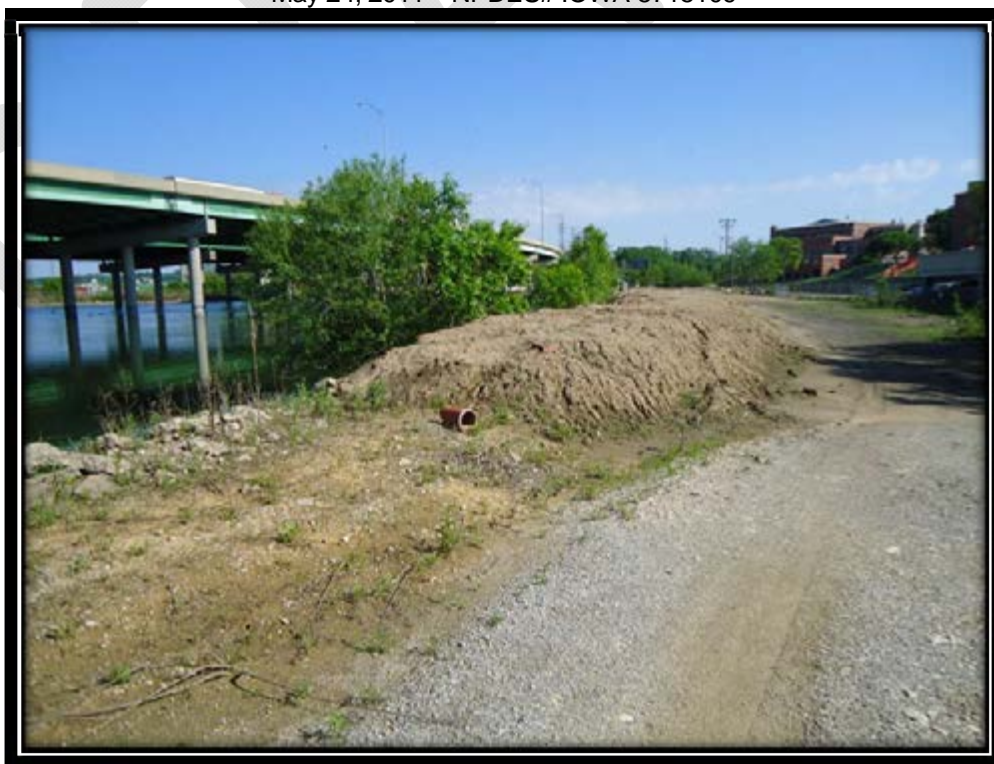
Photo 20 – Ash Pond 3 Embankment (note difference in embankment height)
May 24, 2011 NPDES# IOWA-5715109

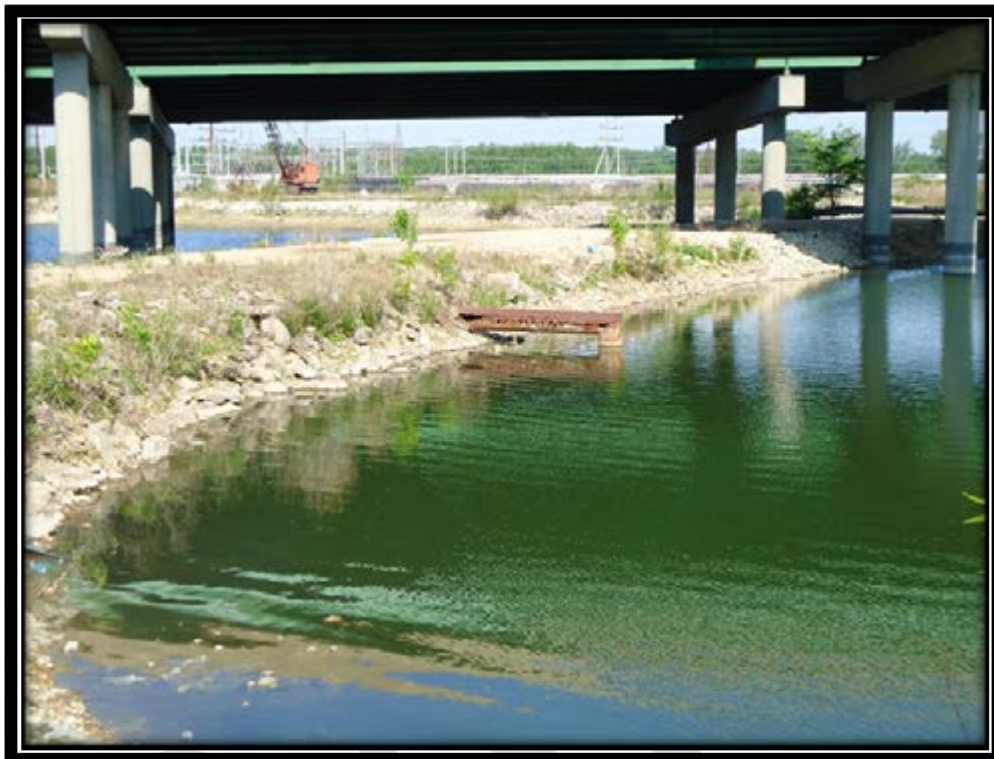
Photo 21 – Ash Pond 3 Outlet Pipe to Ash Pond 4 (note pipe rusted through)
May 24, 2011 NPDES# IOWA-5715109

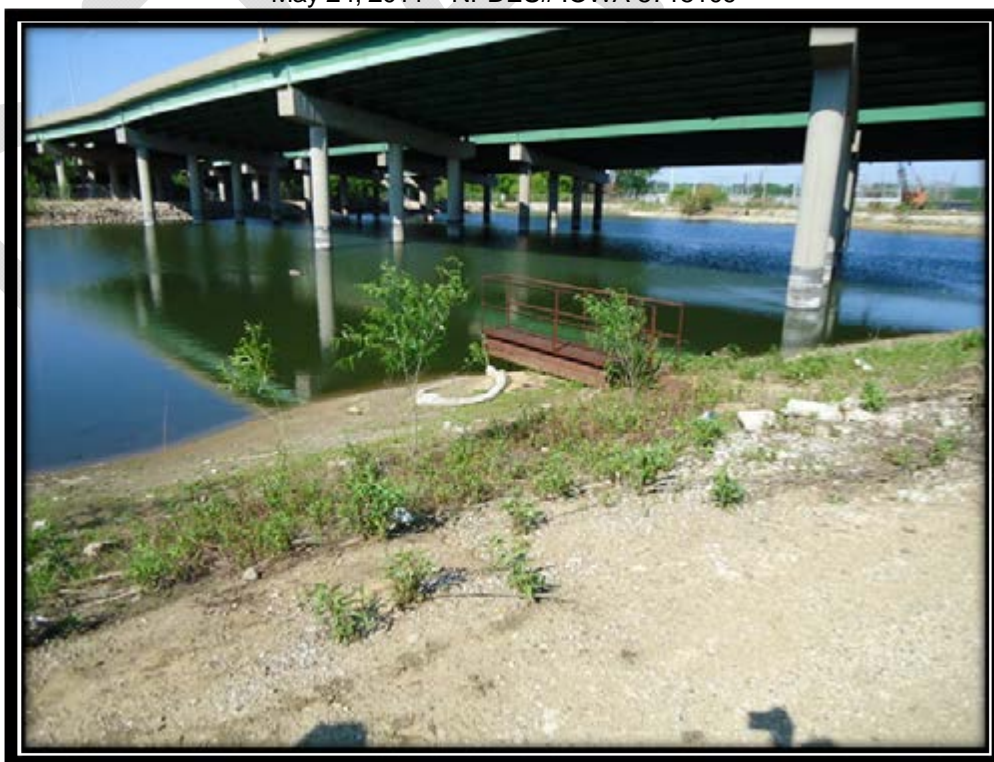
Photo 22 – Ash Pond 4 Inlet Pipe from Pond 3 (note pipe rusted through)
May 24, 2011 NPDES# IOWA-5715109

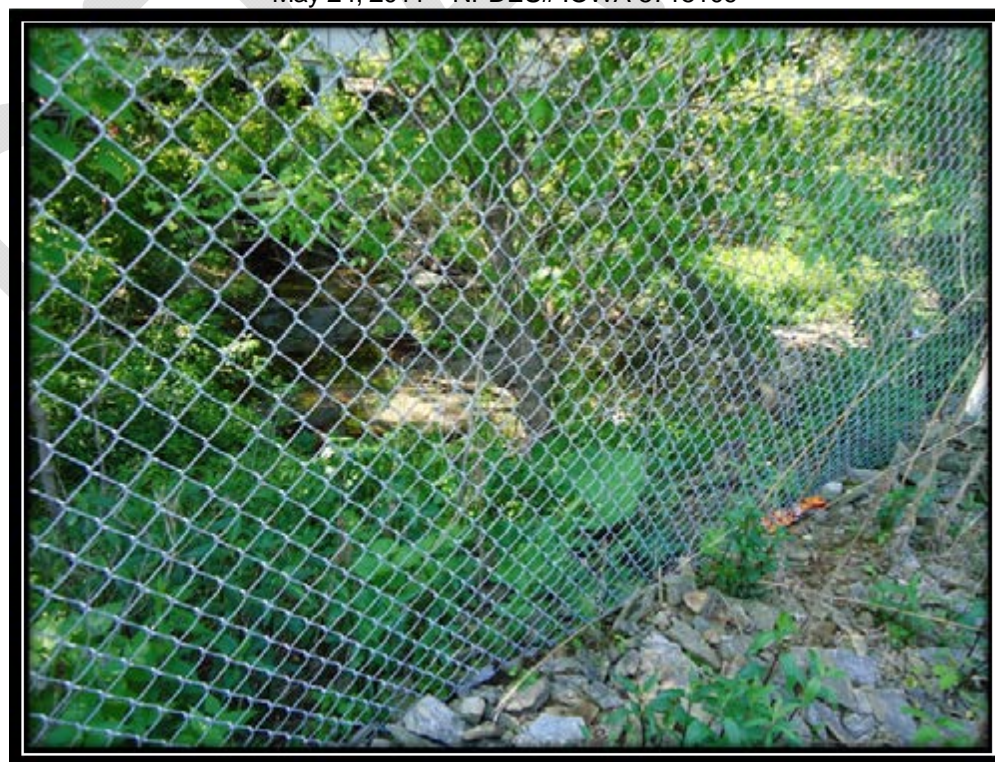
Photo 26 – Ash Pond 4 Downstream Embankment Slope with Heavy Vegetation and Creek at Toe
May 24, 2011 NPDES# IOWA-5715109

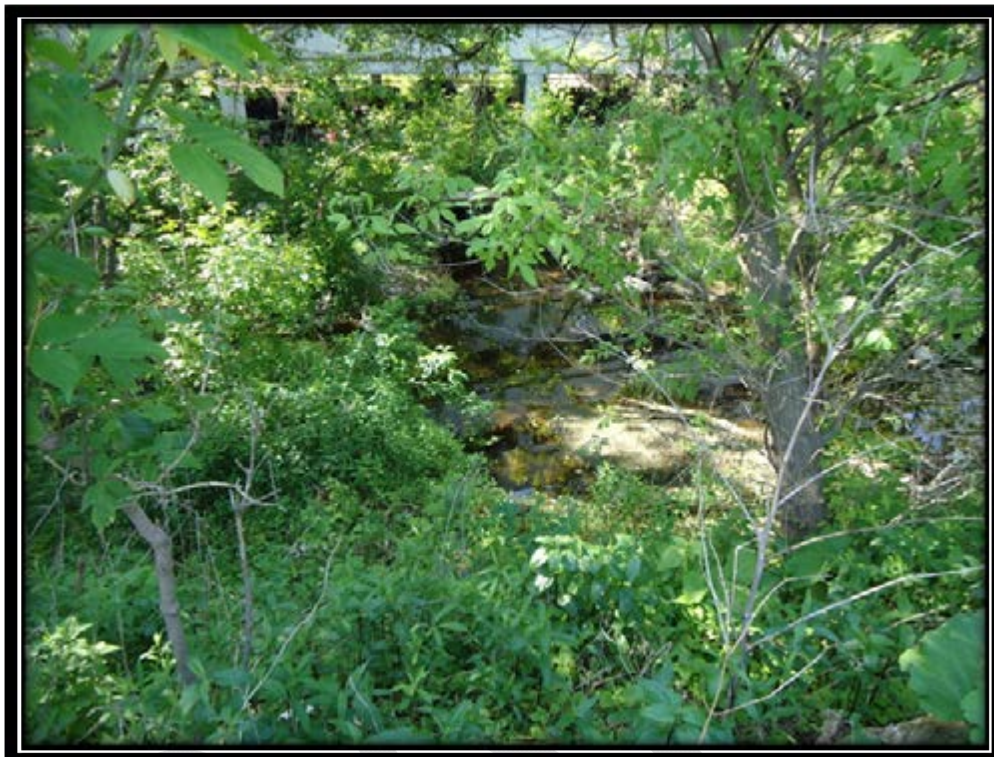
Photo 27 – Ash Pond 4 Landside Embankment Slope with Heavy Vegetation and Creek at Toe
May 24, 2011 NPDES# IOWA-5715109

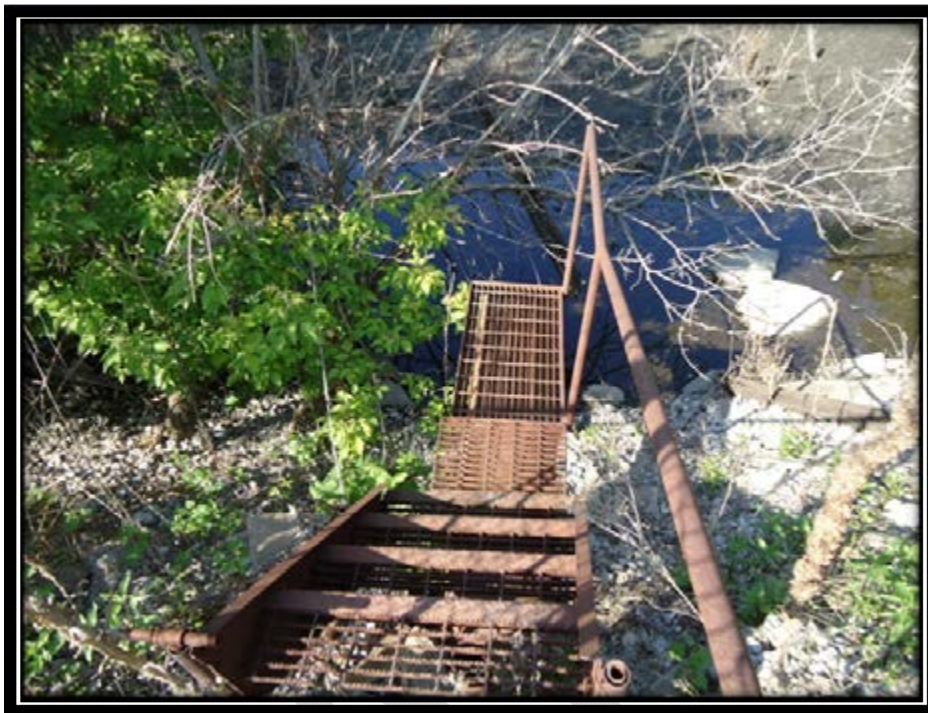
The steel catwalk structure including stairs near the outfall of Pond 4 appears to be in fair condition. The structure as well as the stairs leading to the catwalk appear to be weathered, but not to the point of structural failure. It appears that a hand rail support for the stairs is missing, and should be replaced or studied further to determine the effects of the missing support. Due to the age of the facility, continuous assessment and evaluation is merited to determine the condition of the catwalk and stairs as time progresses.

Photo 29 – Ash Pond 4 Outlet Pipe Outfall and Walkway
May 24, 2011 NPDES# IOWA-5715109

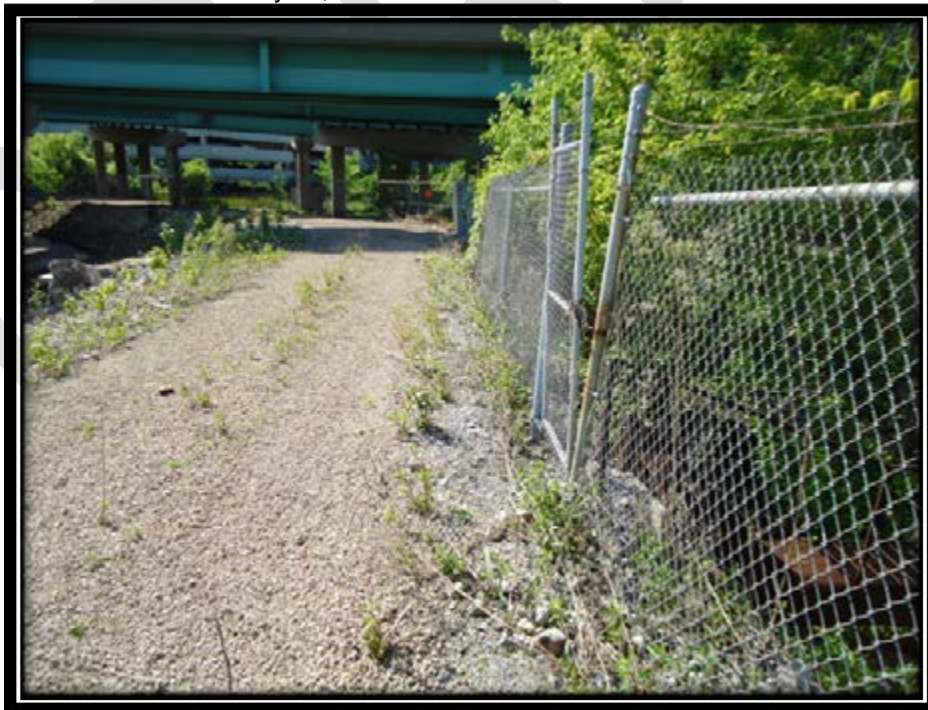
Photo 30 – Ash Pond 4 Fence Penetration at Crest (typical)
May 24, 2011 NPDES# IOWA-5715109

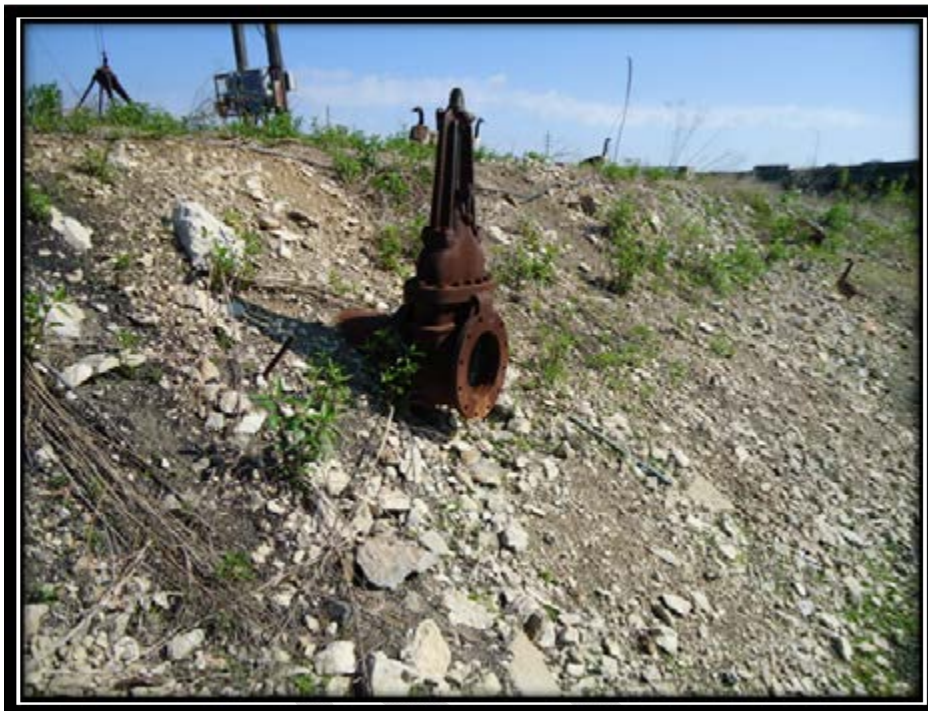
Photo 31 –Ash Pond 4 Inlet Pipe from Ash Pond 1 (note valve)
May 24, 2011 NPDES# IOWA-5715109

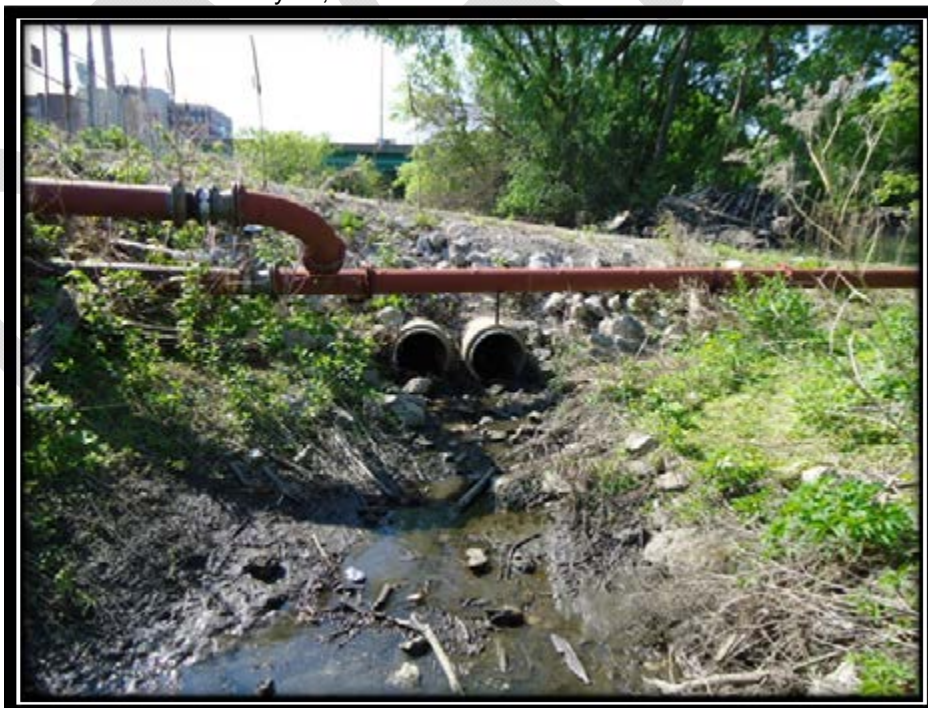
Photo 32 – 24 Inch Reinforced Concrete Pipes in Discharge Channel under Entrance to Ash Ponds
May 24, 2011 NPDES# IOWA-5715109

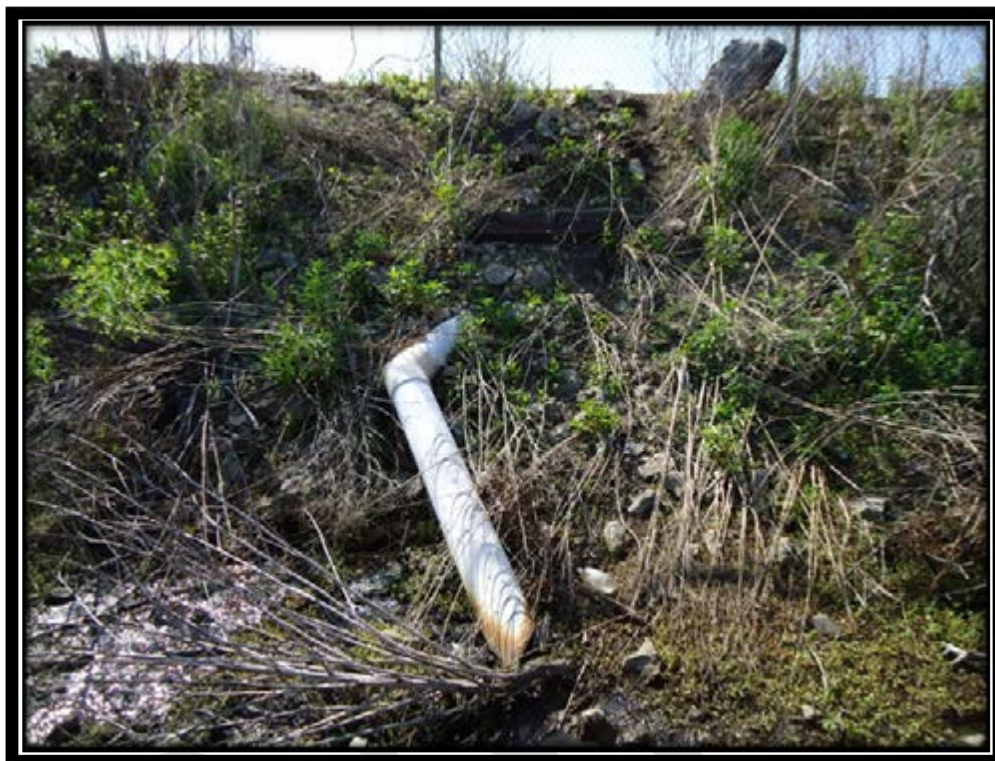
Overall, the downstream slope was in fair to poor condition. Photo 33 at the end of this section shows the condition of the downstream slope. Specific observations include:

- Erosion, some areas close to 6 inches, was noted on some of the downstream slope.
- Penetrations into the downstream embankment, including debris (possibly abandoned pipe), were present.
- Grasses, woody bushes and small trees over 1 inch in diameter were observed on the downstream slope.

Photo 33 – Ash Pond 1 Debris in Downstream Slope of Embankment
May 24, 2011 NPDES# IOWA-5715109

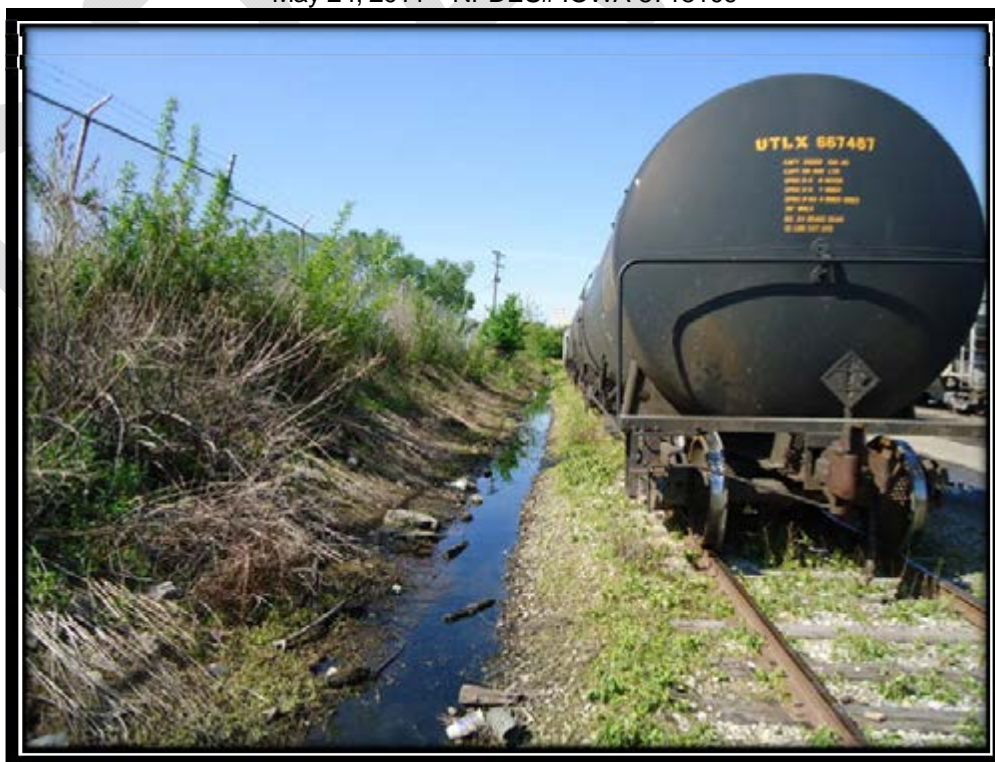
Photo 34 – Downstream Slope of Ash Pond 3 (note ditch at toe)
May 24, 2011 NPDES# IOWA-5715109

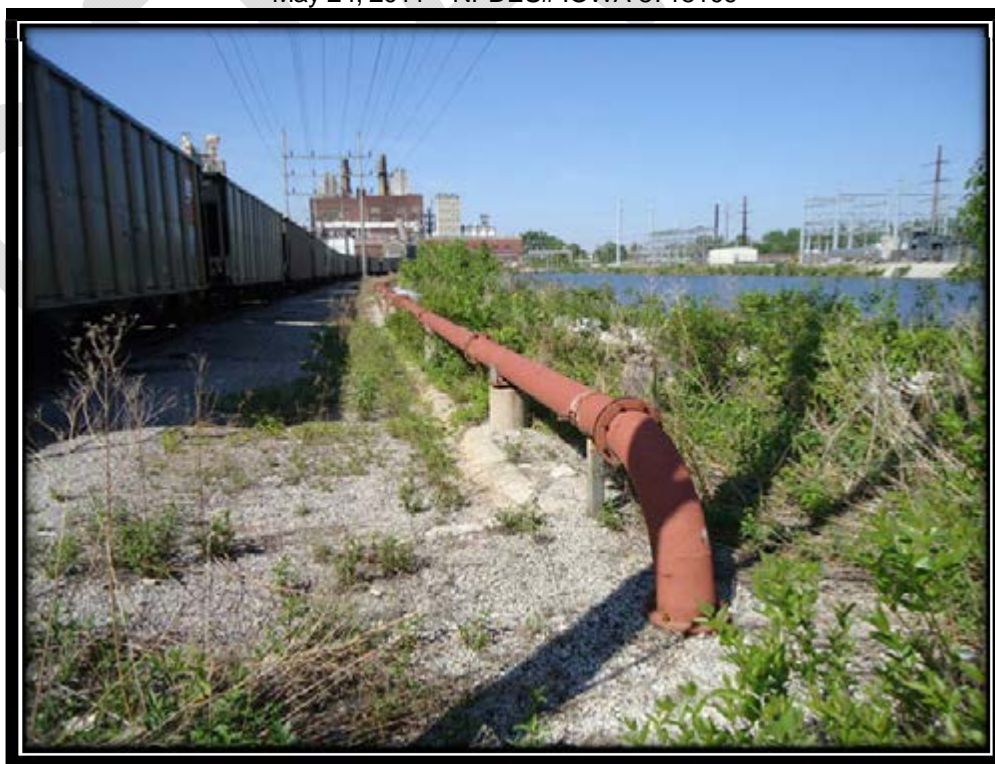
Sluice pipes running from the generating station to the ash ponds appear to be supported on metal and concrete stands that appeared to be weathered, although not to the point of structural failure. Due to the age of the facility, continuous assessment and evaluation is merited to determine the condition of the supports as time progresses.

Photo 36 – Sluice Pipe from Generating Station to Ash Ponds
May 24, 2011 NPDES# IOWA-5715109
